LOWER BLUE CREEK RECONNAISSANCE OF STORED SEDIMENT TECHNICAL MEMORANDUM

Midnite Mine Superfund Site – Spokane Indian Reservation, WA

Revision 2

September 2015

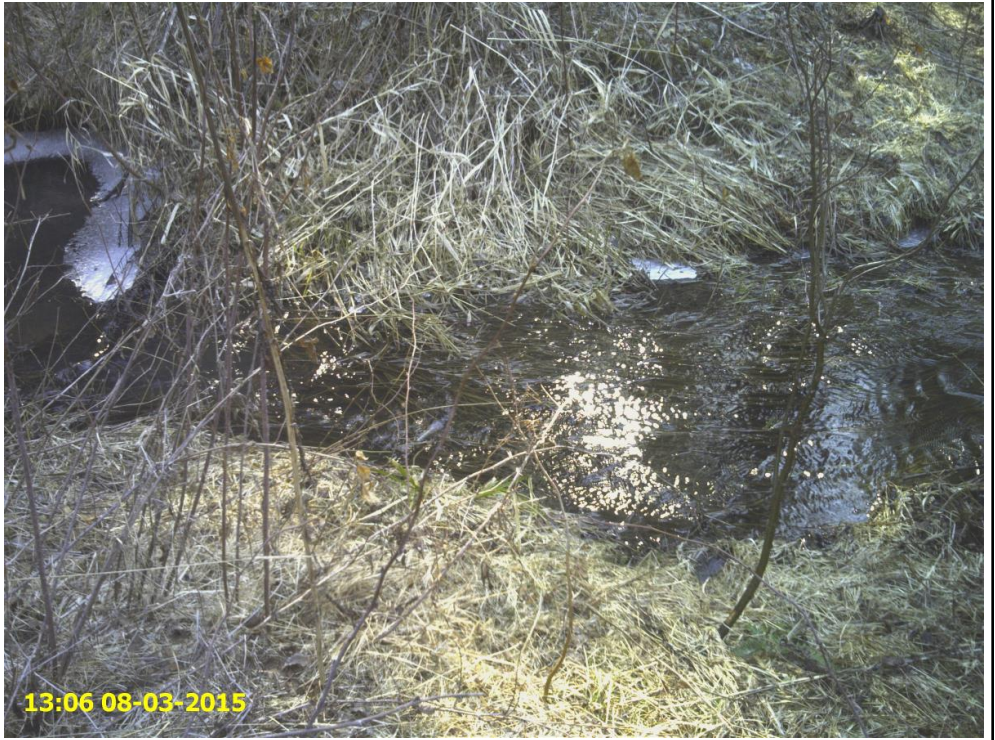
Client:	Newmont	Project:	Lower Blue Creek Reconnaissance
Site Name:	Midnite Mine	Site Location:	Lower Blue Creek
Photograph ID: 1

Photo Location: Upper Reach, Station U-A, Profile 1			
Direction:			
Survey Date: 3/8/2015			
Comments: Riffle/Pool stream type			
Photograph ID: 2

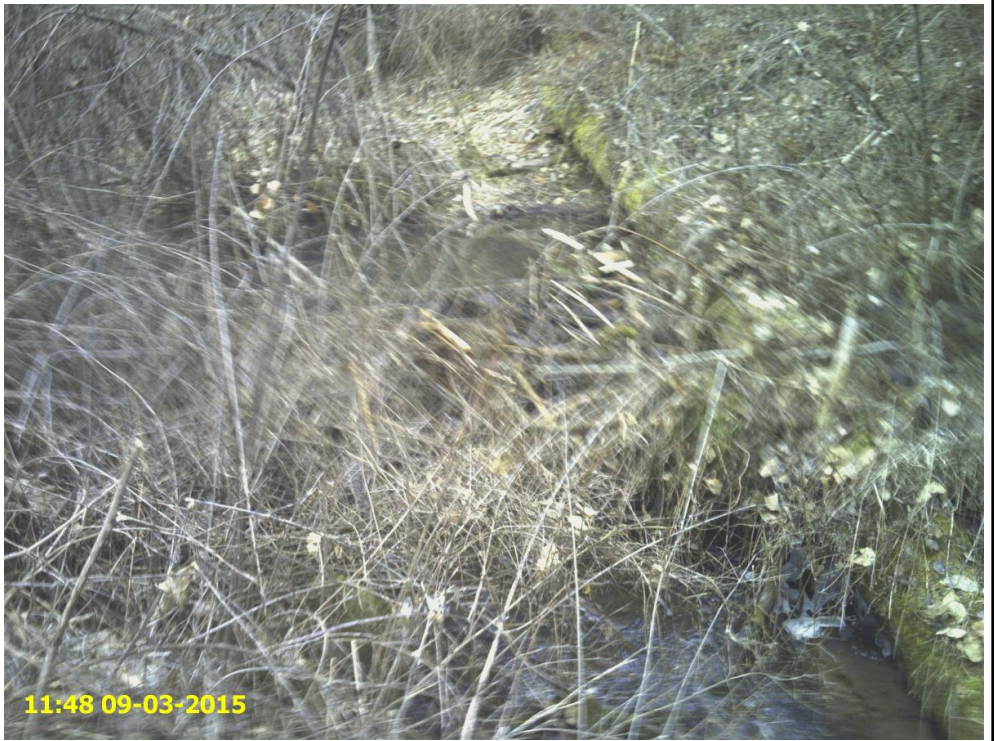
Photo Location: Upper Reach, Station U-B, Beaver Dam			
Direction:			
Survey Date: 3/9/2015			
Comments: Beaver dam part of a six-dam complex in the upper reach.

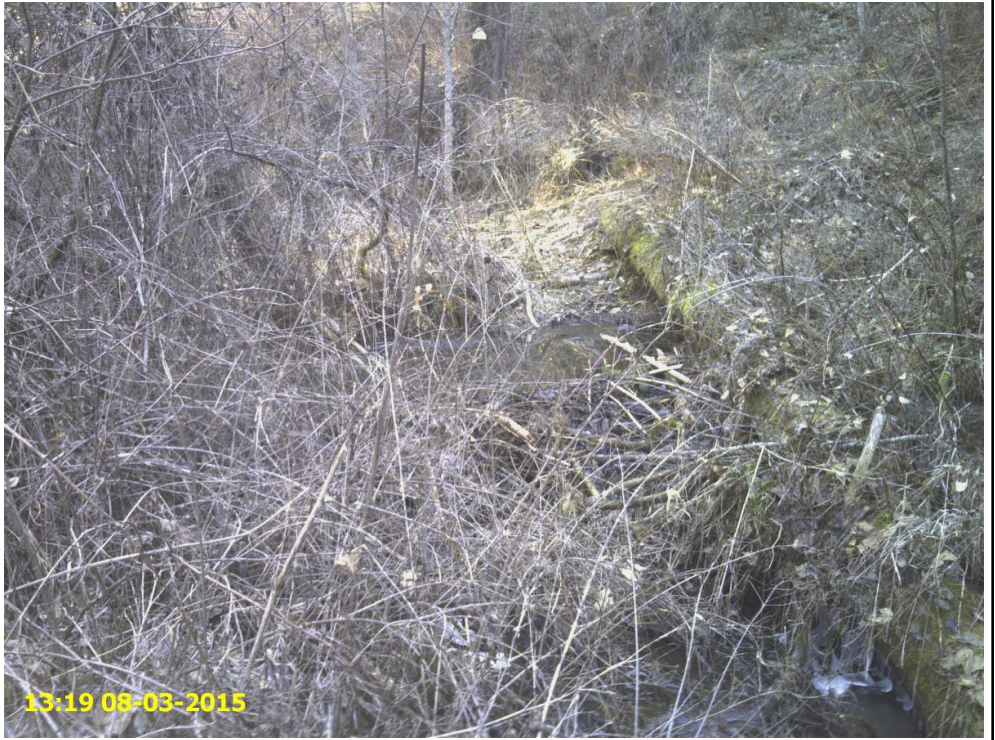
Client:	Newmont	Project:	Lower Blue Creek Reconnaissance
Site Name:	Midnite Mine	Site Location:	Lower Blue Creek
Photograph ID: 3

Photo Location: Upper Reach, Station U-C, Beaver Dam			
Direction:			
Survey Date: 3/8/2015			
Comments: Beaver dam part of a six-dam complex in the upper reach.			
Photograph ID: 4

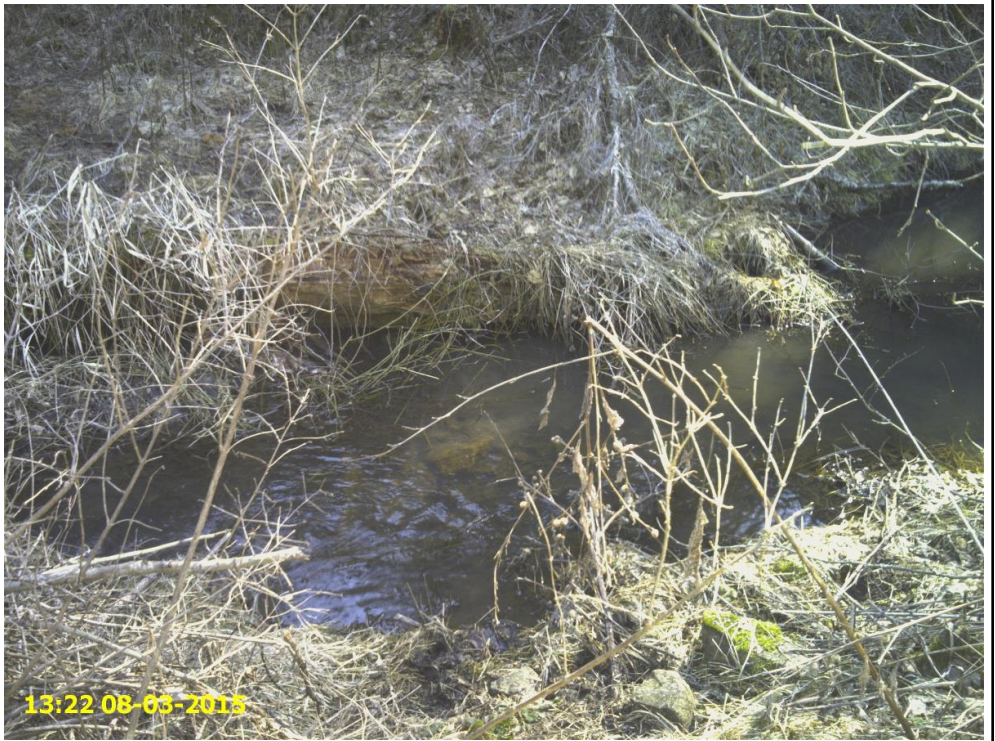
Photo Location: Upper Reach, Station U-C, Profile 1			
Direction:			
Survey Date: 3/8/2015			
Comments: Channel is deeply incised into the fluvial bench deposits.

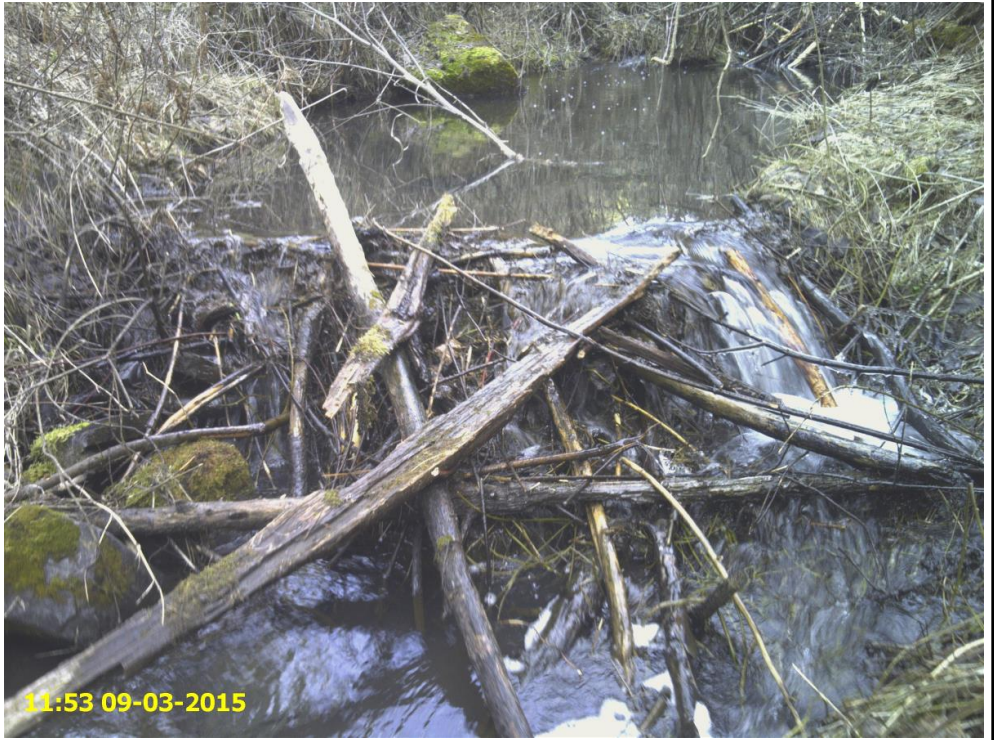
Client:	Newmont	Project:	Lower Blue Creek Reconnaissance
Site Name:	Midnite Mine	Site Location:	Lower Blue Creek
Photograph ID: 5

Photo Location: Upper Reach, Station U-D, Beaver Dam			
Direction:			
Survey Date: 3/9/2015			
Comments: Beaver dam part of a six-dam complex in the upper reach.			
Photograph ID: 6

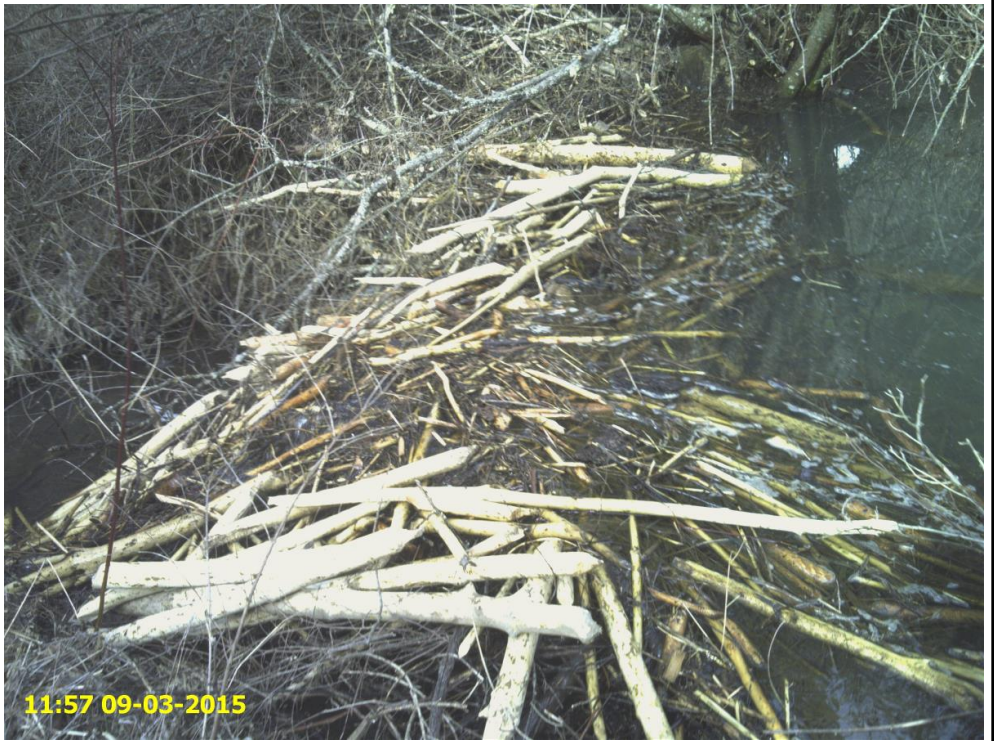
Photo Location: Upper Reach, Station U-F, Beaver Dam			
Direction:			
Survey Date: 3/9/2015			
Comments: Beaver dam part of a six-dam complex in the upper reach.

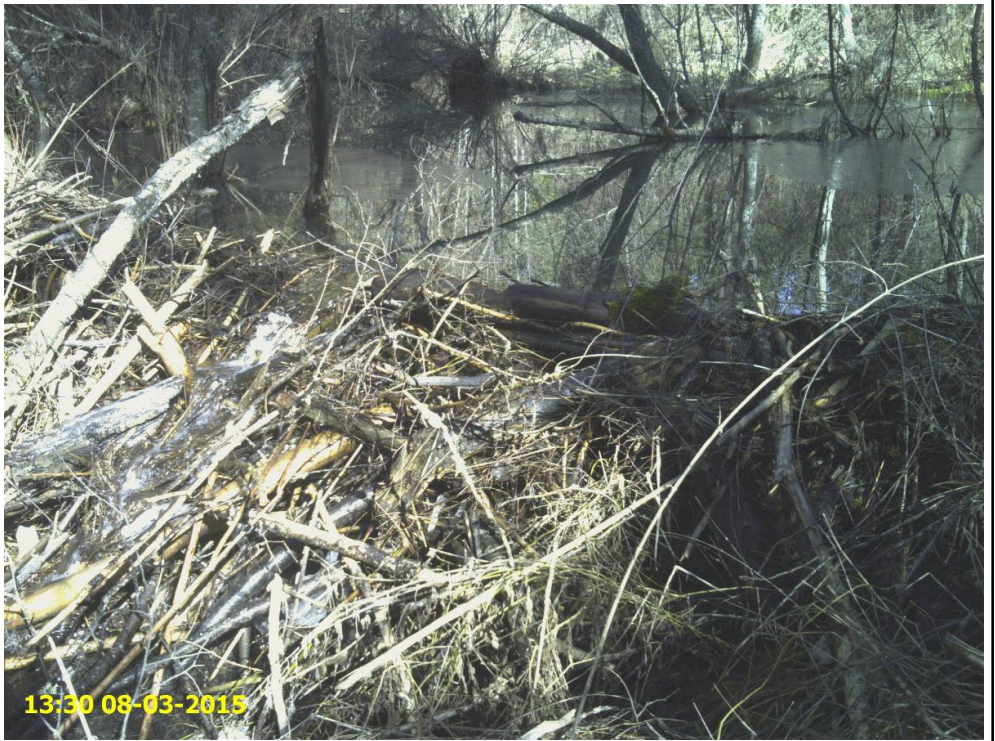
Photo Location: Upper Reach, Station U-H, Beaver Dam			
Direction:			
Survey Date: 3/8/2015			
Comments: Medium size beaver dam and pool are shown.

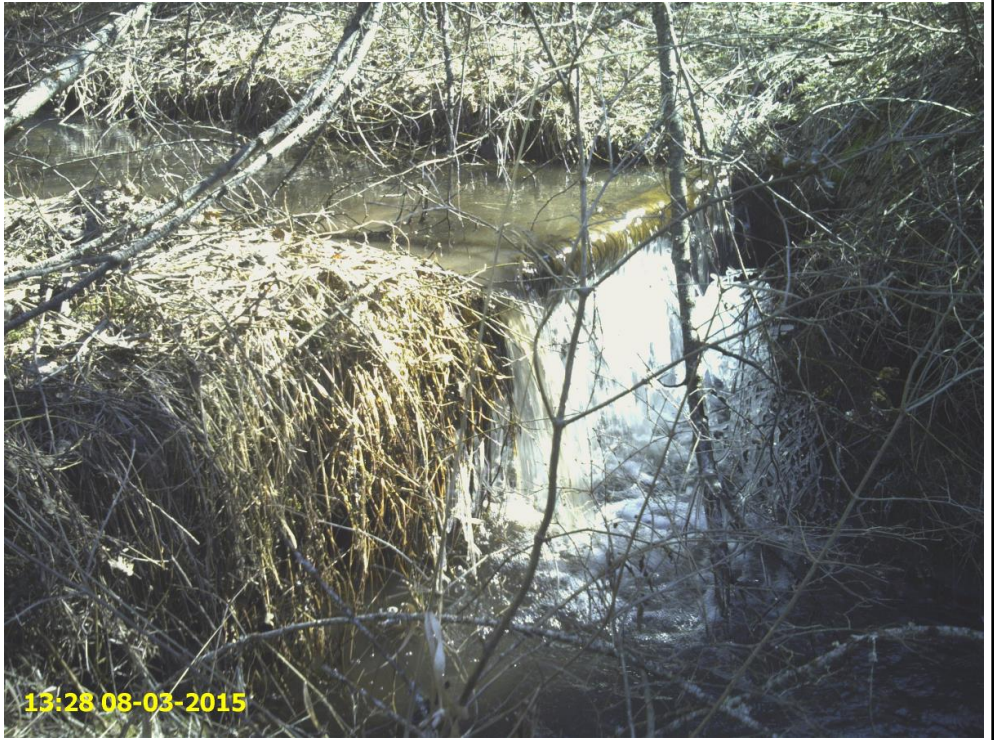
Client:	Newmont	Project:	Lower Blue Creek Reconnaissance
Site Name:	Midnite Mine	Site Location:	Lower Blue Creek
Photograph ID: 9

Photo Location: Upper Reach, Station U-H, Log Weir			
Direction:			
Survey Date: 3/8/2015			
Comments: One of several man-made log weirs in the upper reach.			
Photograph ID: 10

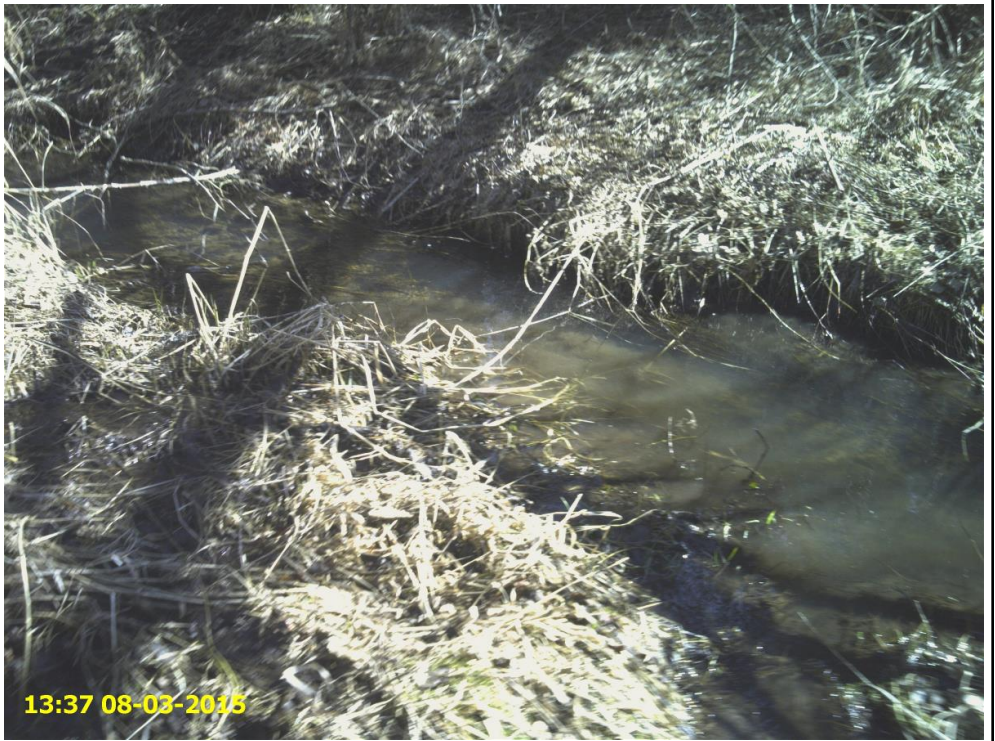
Photo Location: Upper Reach, Station U-H, Profile 1			
Direction:			
Survey Date: 3/8/2015			
Comments: Channel is deeply incised into the fluvial bench deposits.

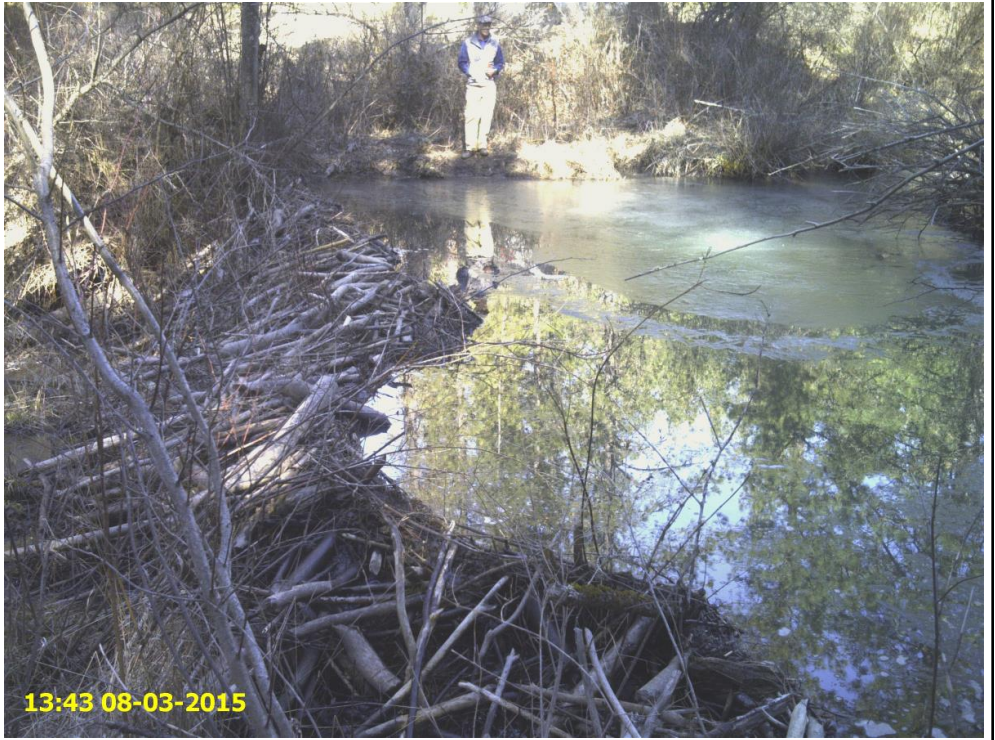
Client:	Newmont	Project:	Lower Blue Creek Reconnaissance
Site Name:	Midnite Mine	Site Location:	Lower Blue Creek
Photograph ID: 11

Photo Location: Upper Reach, Station U-I, Beaver Dam			
Direction:			
Survey Date: 3/8/2015			
Comments: The lower of the two uppermost and largest beaver dams.			
Photograph ID: 12

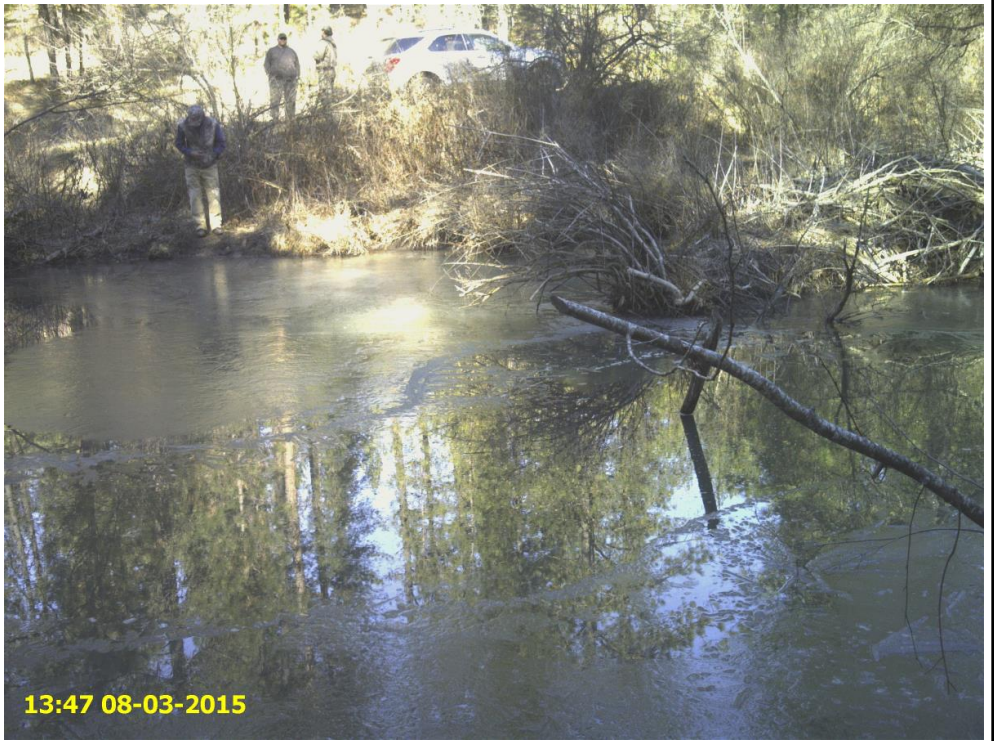
Photo Location: Upper Reach, Station U-I, Profile 1			
Direction:			
Survey Date: 3/8/2015			
Comments: The lower of the two uppermost and largest beaver ponds.

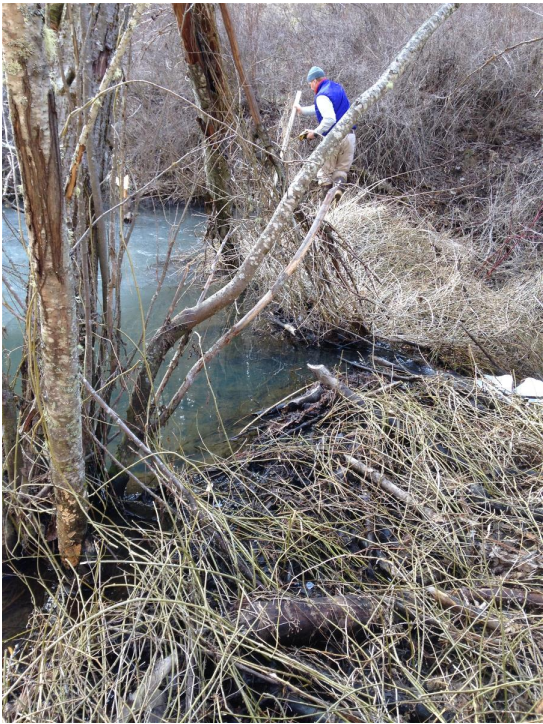
Client:	Newmont	Project:	Lower Blue Creek Reconnaissance
Site Name:	Midnite Mine	Site Location:	Lower Blue Creek
Photograph ID: 13

Photo Location: Upper Reach, Station U-J, Beaver Dam			
Direction:			
Survey Date: 3/9/2015			
Comments: Uppermost beaver dam. The dam is heavily vegetated.			
Photograph ID: 14

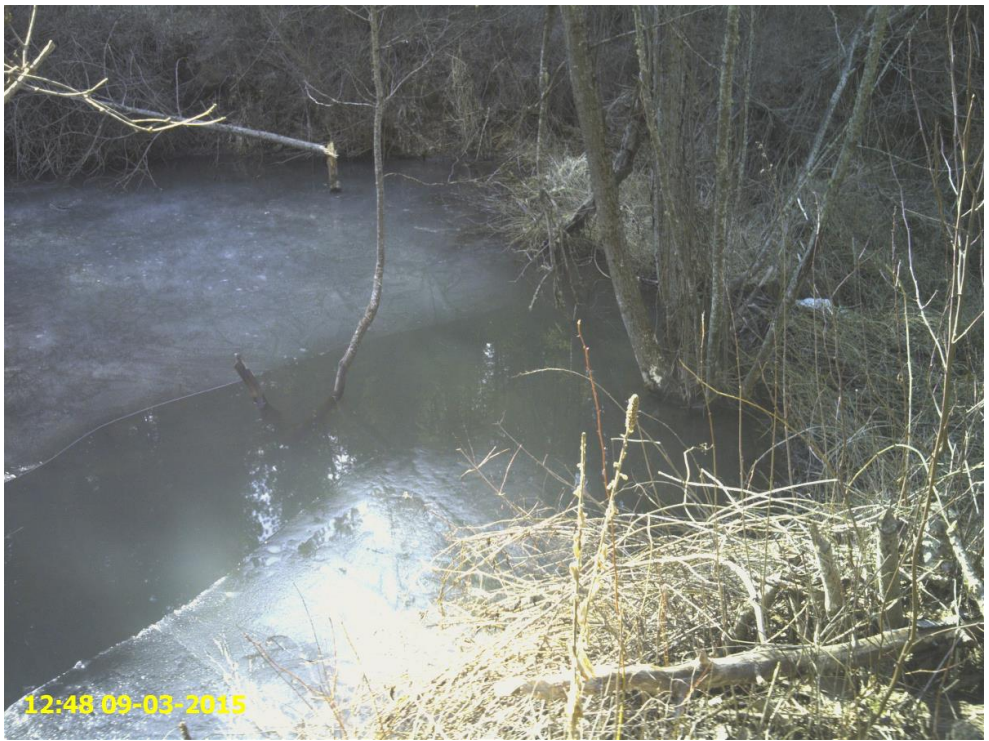
Photo Location: Upper Reach, Station U-J, Beaver Dam			
Direction:			
Survey Date: 3/9/2015			
Comments: The uppermost and second largest beaver dam observed.

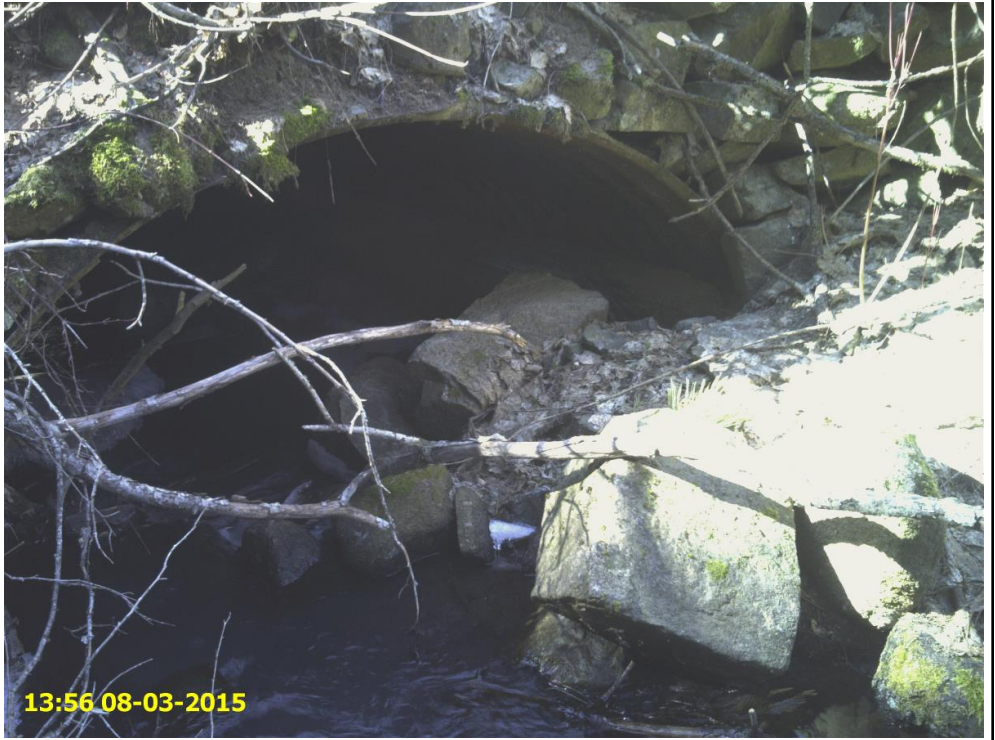
Client:	Newmont	Project:	Lower Blue Creek Reconnaissance
Site Name:	Midnite Mine	Site Location:	Lower Blue Creek
Photograph ID: 15

Photo Location: Upper Reach, the Culvert beneath the Elijah Road			
Direction:			
Survey Date: 3/8/2015			
Comments: Approximately 72 inch diameter culvert.			
Photograph ID: 16

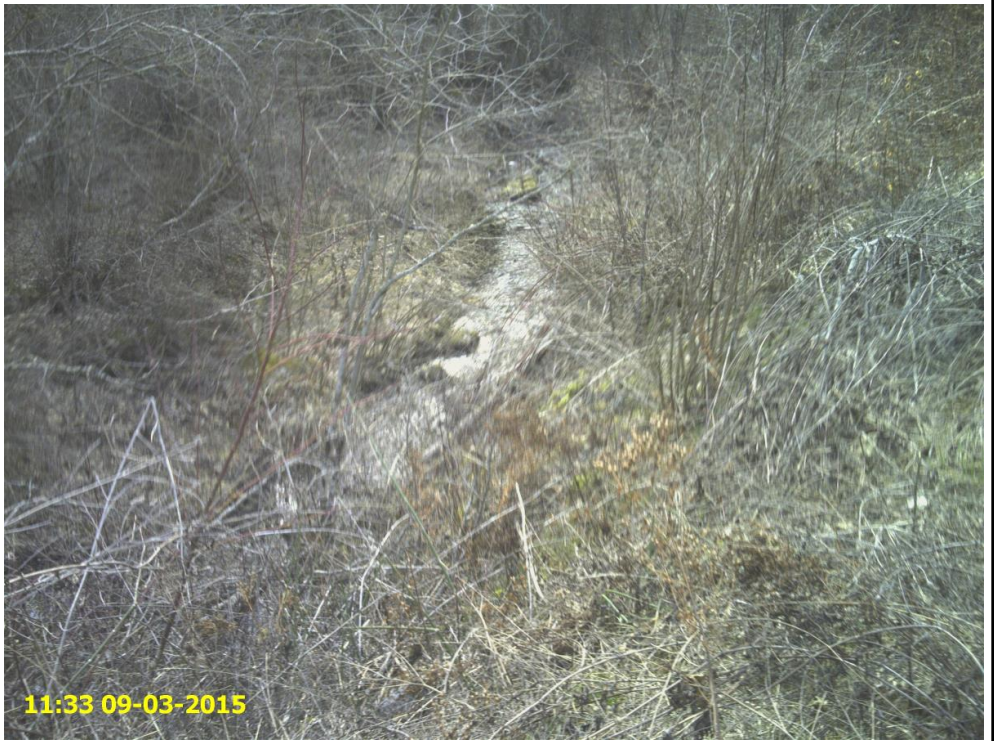
Photo Location: Middle Reach, Station M-A			
Direction:			
Survey Date: 3/9/2015			
Comments: Lookind down approximately 30 feet to Blue Creek from road. The creek is steep in this reach and depositional areas or beaver dams are not observed.

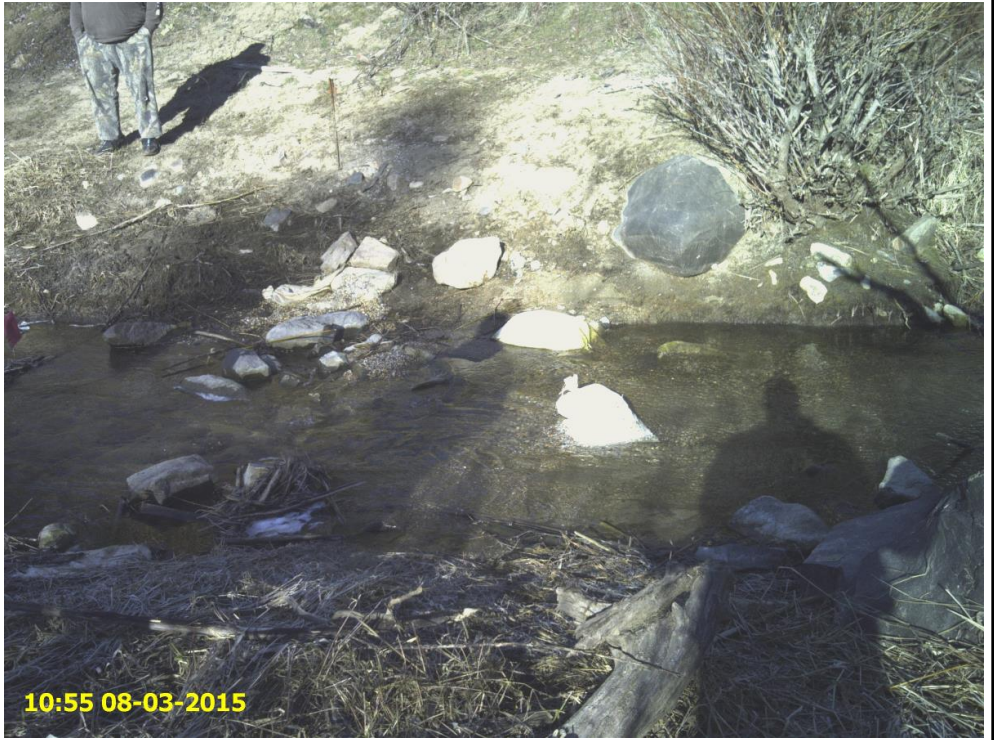
Client:	Newmont	Project:	Lower Blue Creek Reconnaissance
Site Name:	Midnite Mine	Site Location:	Lower Blue Creek
Photograph ID: 17

Photo Location: Lower Reach, Station L-A, Profile 1			
Direction:			
Survey Date: 3/8/2015			
Comments: The creek at this location is a riffle stream type with large boulders.			
Photograph ID: 18

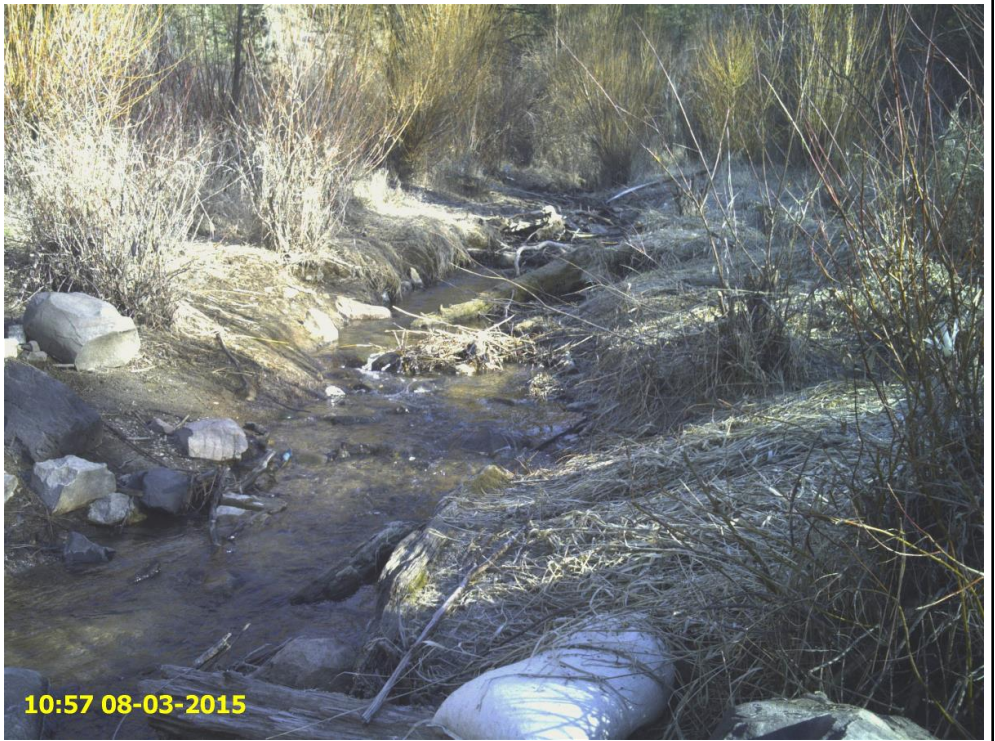
Photo Location: Lower Reach, Station L-A			
Direction:			
Survey Date: 3/8/2015			
Comments: The creek at this location is a riffle stream type with large boulders.

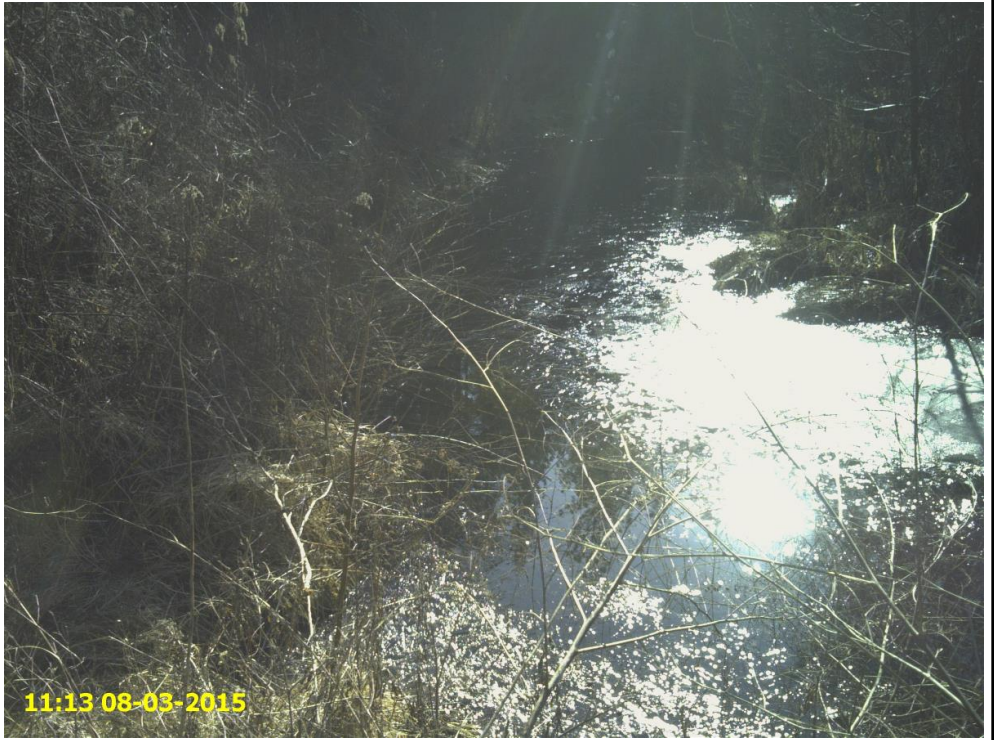
Client:	Newmont	Project:	Lower Blue Creek Reconnaissance
Site Name:	Midnite Mine	Site Location:	Lower Blue Creek
Photograph ID: 21

Photo Location: Lower Reach, Station L-B			
Direction:			
Survey Date: 3/8/2015			
Comments: Depositional area created by beaver dam.			
Photograph ID: 22	 		
Photo Location: Lower Reach, Station L-C, Beaver Pond			
Direction:			
Survey Date: 3/9/2015			
Comments: View of a larger beaver pond in the lower reach.

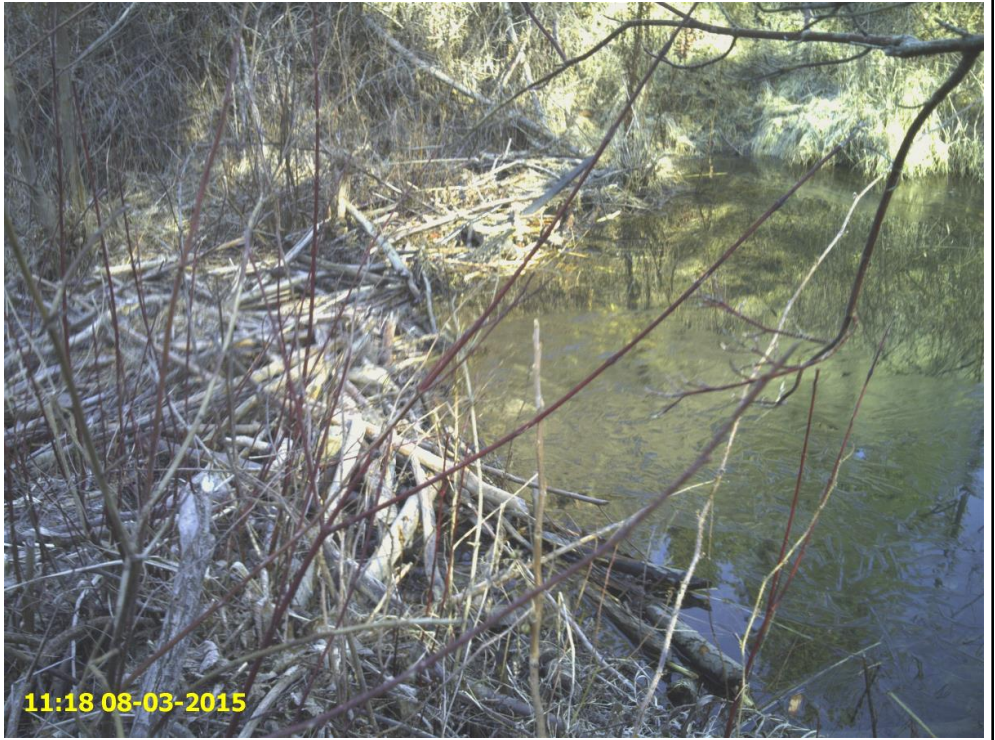
Client:	Newmont	Project:	Lower Blue Creek Reconnaissance
Site Name:	Midnite Mine	Site Location:	Lower Blue Creek
Photograph ID: 23

Photo Location: Lower Reach, Station L-C, Beaver Dam			
Direction:			
Survey Date: 3/8/2015			
Comments: Beaver dams in the lower reach are small and apparently relatively recent.			
Photograph ID: 24

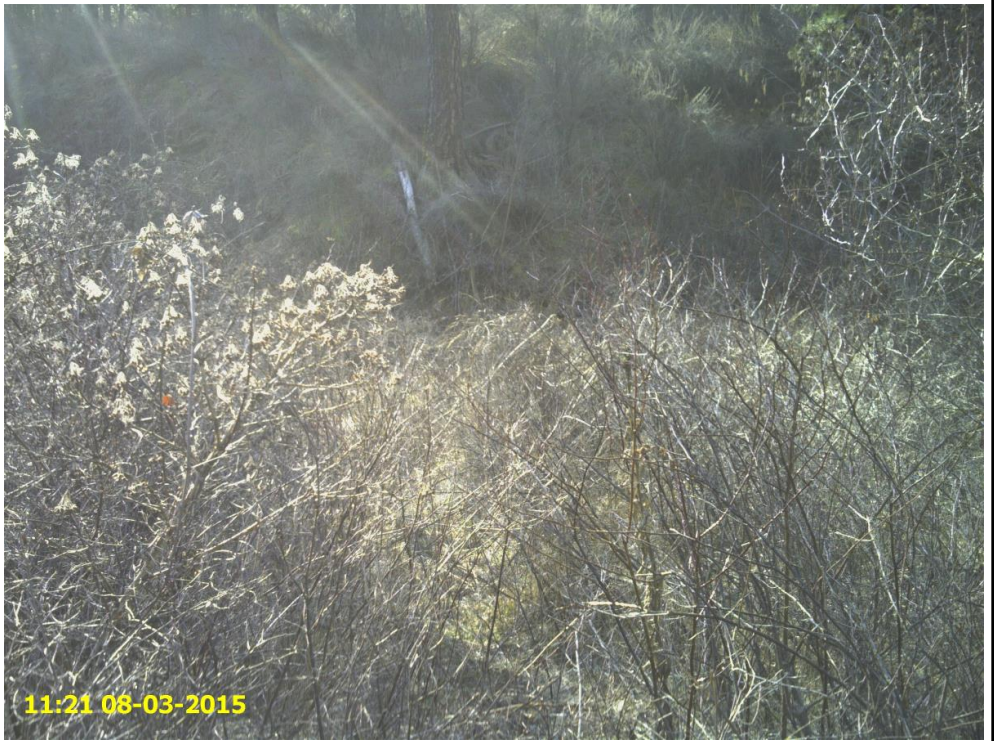
Photo Location: Lower Reach, Station L-C, Profile 1			
Direction:			
Survey Date: 3/8/2015			
Comments: Beaver dams in the lower reach are small and apparently relatively recent.

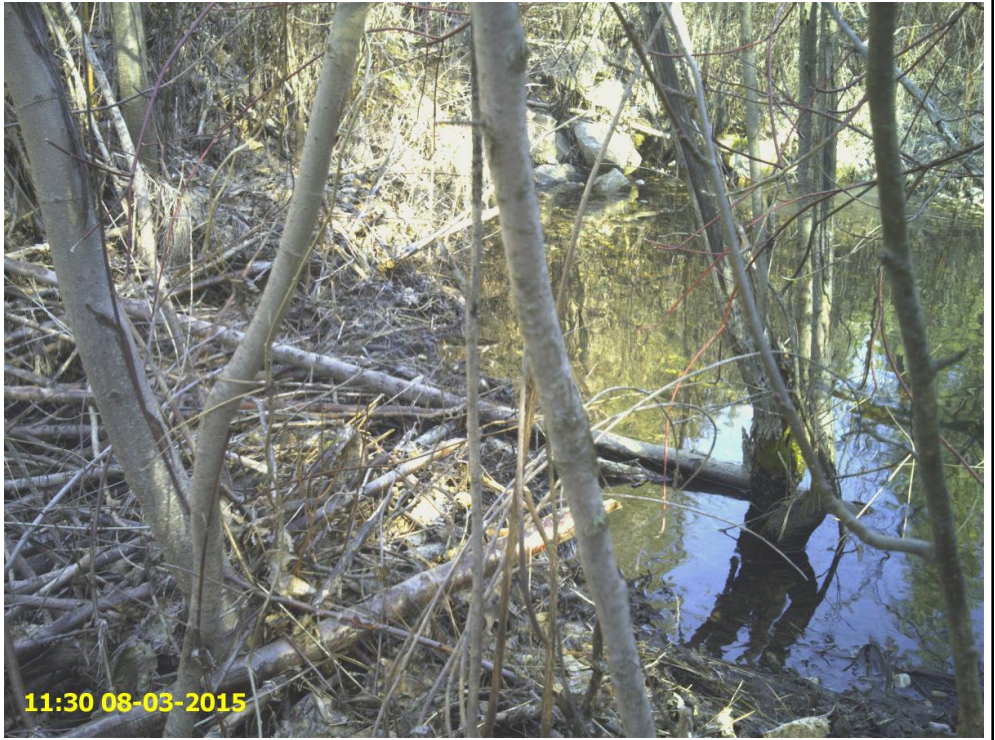
Client:	Newmont	Project:	Lower Blue Creek Reconnaissance
Site Name:	Midnite Mine	Site Location:	Lower Blue Creek
Photograph ID: 25

Photo Location: Lower Reach, Station L-D, Beaver Dam			
Direction:			
Survey Date: 3/8/2015			
Comments:			
Photograph ID: 26

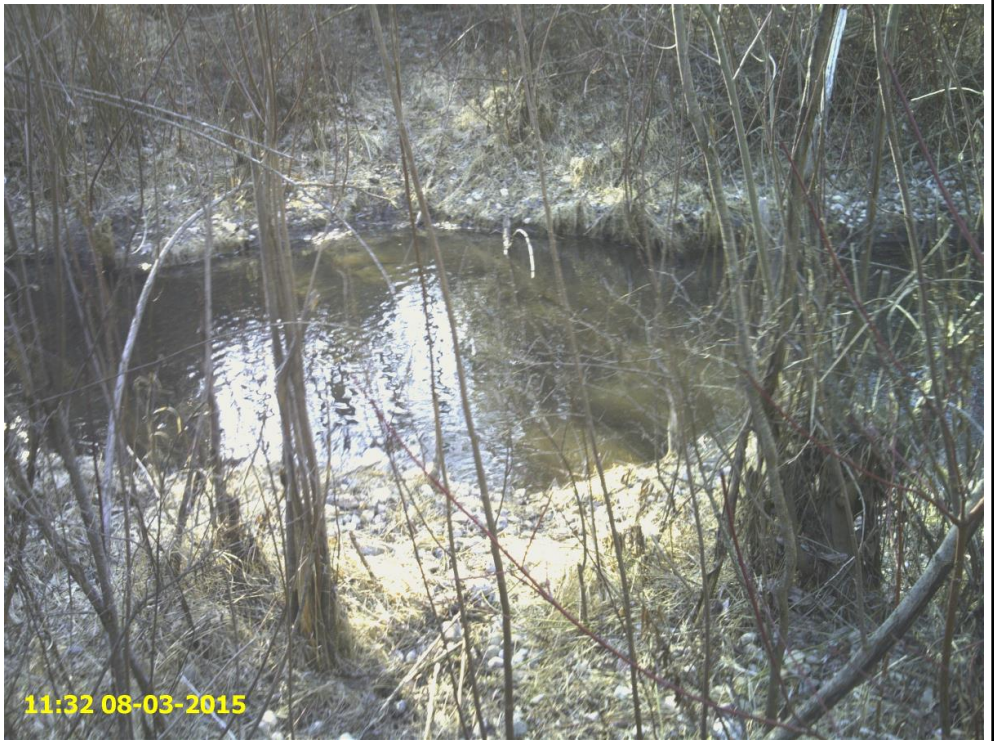
Photo Location: Lower Reach, Station L-D, Profile 1			
Direction:			
Survey Date: 3/8/2015			
Comments: Fluvial bench deposits are typically vegetated with rushes, grasses, forbs and shrubs.

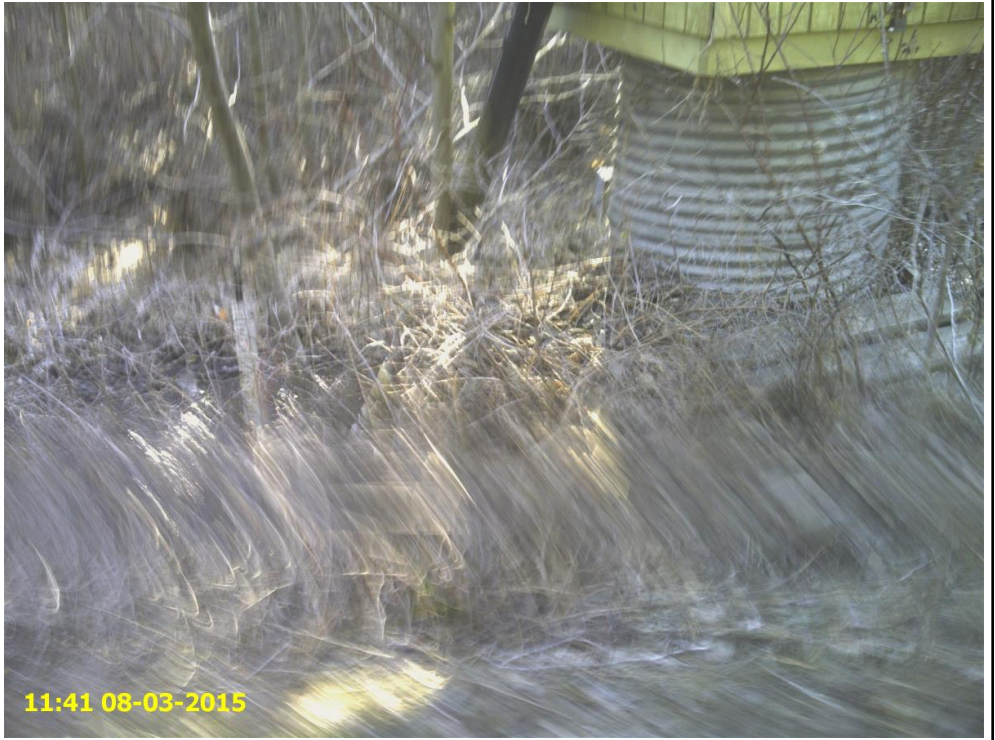
Client:	Newmont	Project:	Lower Blue Creek Reconnaissance
Site Name:	Midnite Mine	Site Location:	Lower Blue Creek
Photograph ID: 27

Photo Location: Lower Reach, Station L-D, Stream Gauging Station			
Direction:			
Survey Date: 3/8/2015			
Comments: Gauge at 0.30 feet on this day at 1041.			
Photograph ID: 28

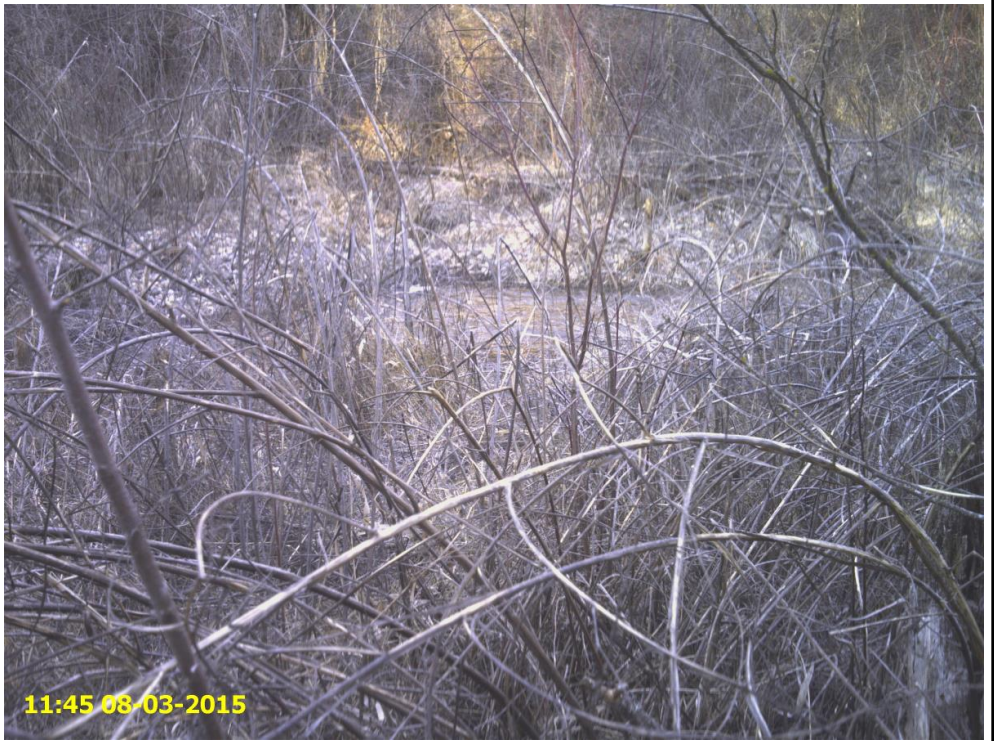
Photo Location: Lower Reach, Station L-E, Profile 1			
Direction:			
Survey Date: 3/8/2015			
Comments: Riffle stream type at this profile location.

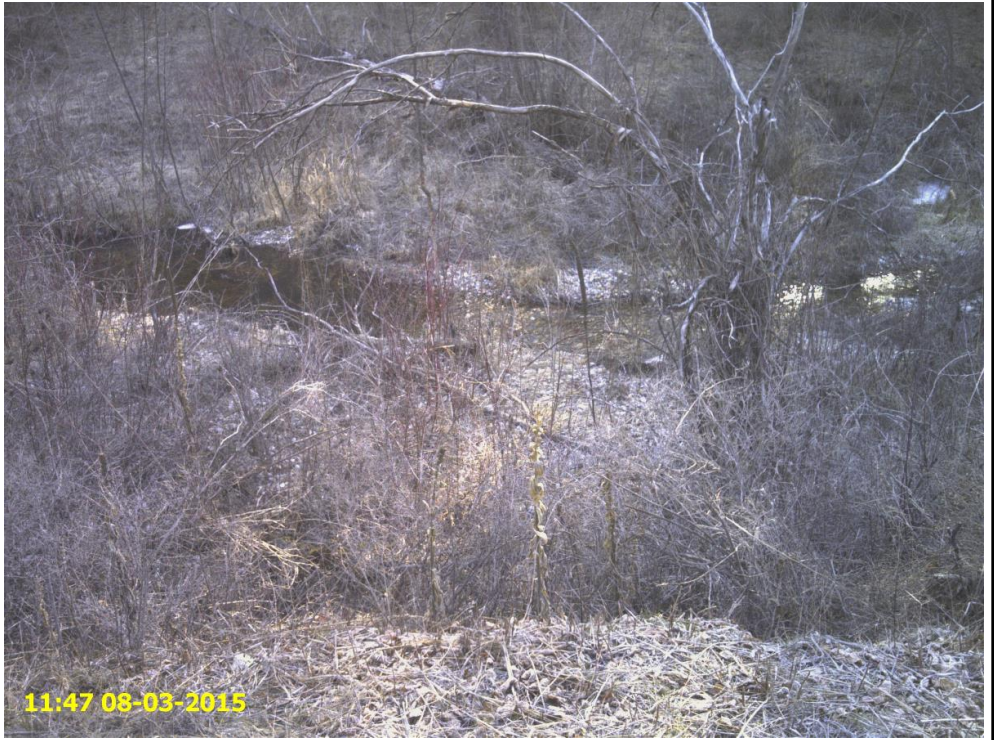
Client:	Newmont	Project:	Lower Blue Creek Reconnaissance
Site Name:	Midnite Mine	Site Location:	Lower Blue Creek
Photograph ID: 29

Photo Location: Lower Reach, Station L-E			
Direction:			
Survey Date: 3/8/2015			
Comments: This photo shows the typical condition of the primary fluvial bench which exists 1-3 feet above the creek bottom and is heavily vegetated.			
Photograph ID: 30

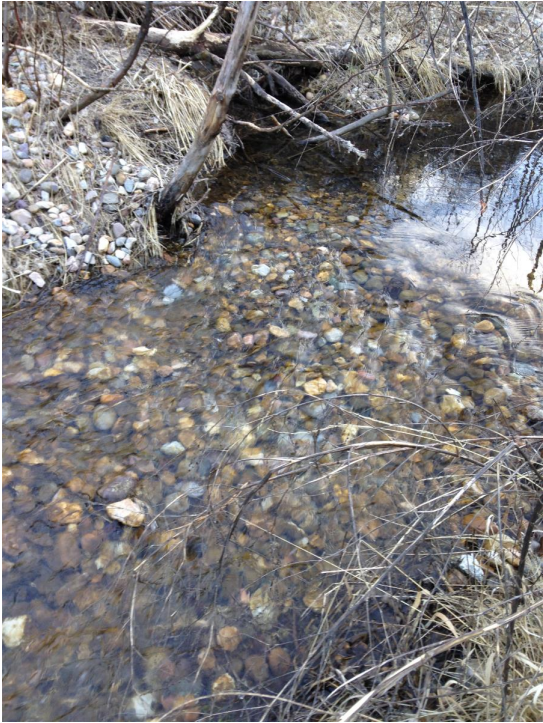
Photo Location: Lower Reach, Station L-E, Gravel			
Direction:			
Survey Date: 3/9/2015			
Comments: Gravel added by the Tribe DNR to support spawning.

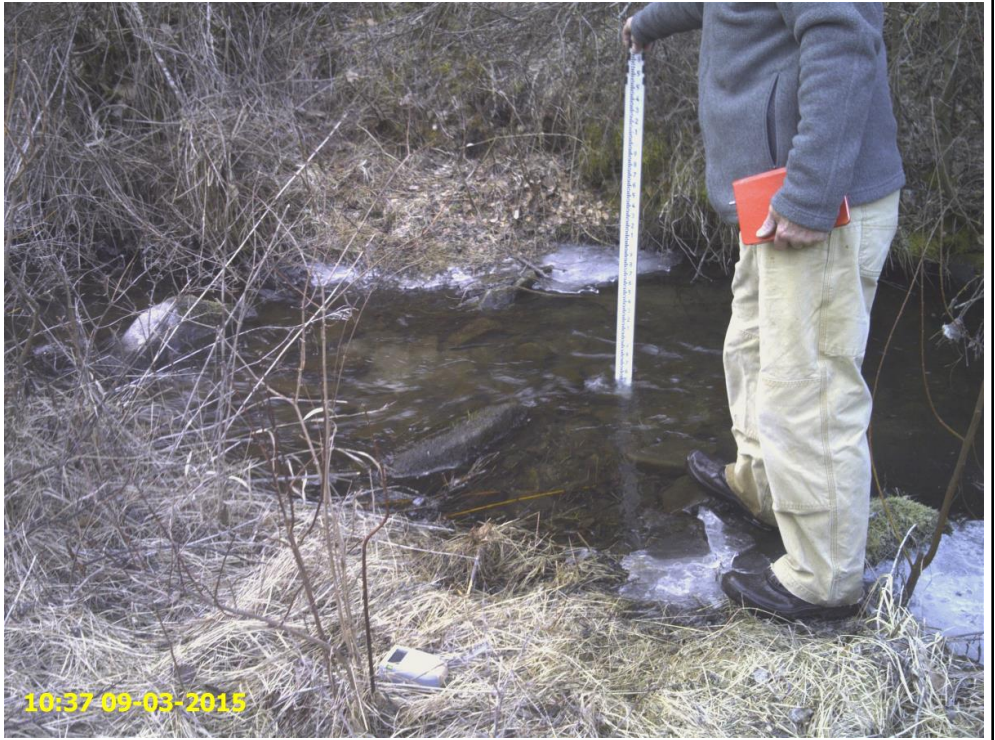
Client:	Newmont	Project:	Lower Blue Creek Reconnaissance
Site Name:	Midnite Mine	Site Location:	Lower Blue Creek
Photograph ID: 31

Some of these small deposits are shown in photos in Appendix A (e.g., photo IDs 22 and 31). The majority of the unconsolidated materials observed on the creek bottom are gravel, cobble, and boulder-sized material.

Photo Location: Lower Reach, Station L-F, Profile			
Direction:			
Survey Date: 3/9/2015			
Comments: Stadia rod and laser level shown used to measure fluvial bench deposit thickness.			
Photograph ID: 32

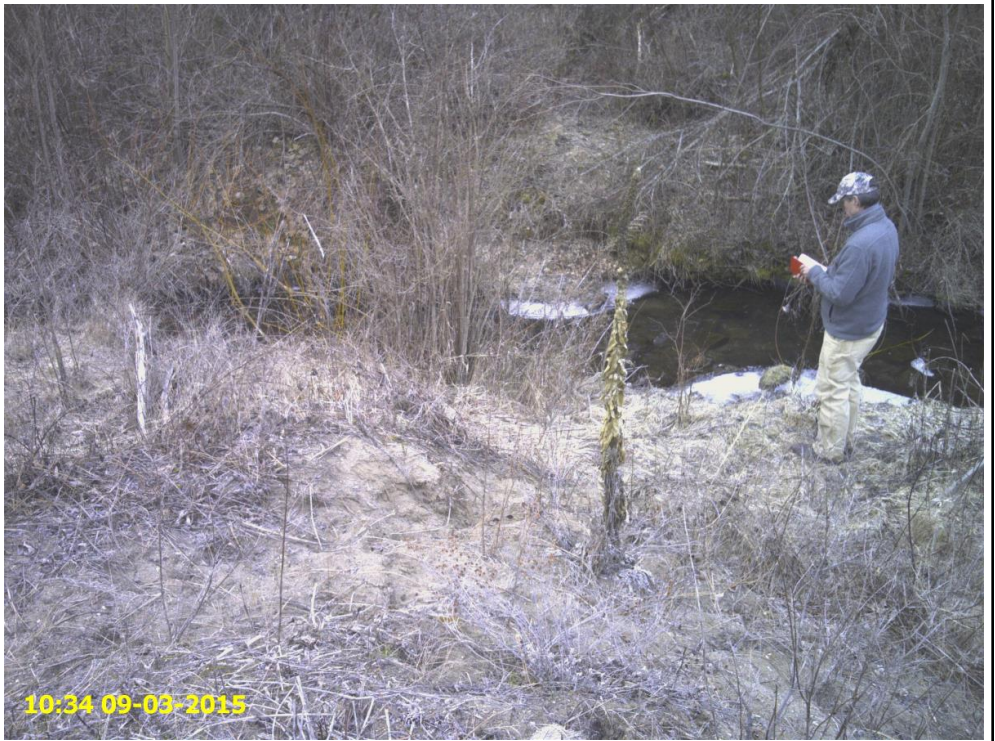
Photo Location: Lower Reach, Station L-F			
Direction:			
Survey Date: 3/9/2015			
Comments: Pool stream type, the person shown is standing on the primary fluvial bench deposits.

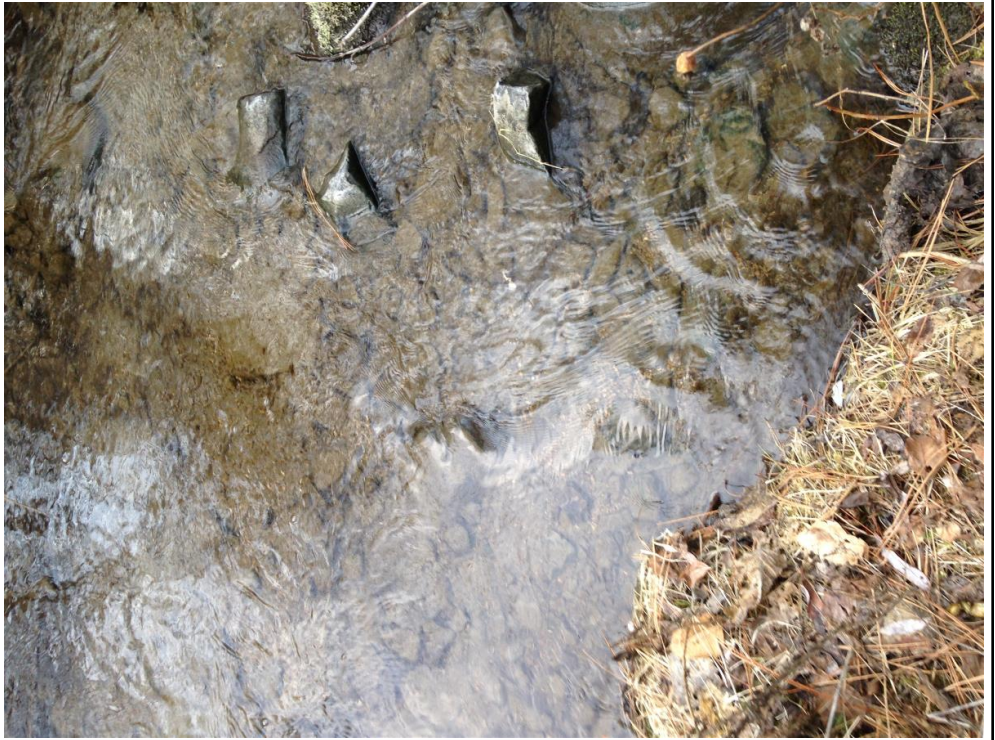
Client:	Newmont	Project:	Lower Blue Creek Reconnaissance
Site Name:	Midnite Mine	Site Location:	Lower Blue Creek
Photograph ID: 35

Photo Location: Lower Reach, Station L-I			
Direction:			
Survey Date: 3/9/2015			
Comments: Stream bottom composition of gravel with sand-sized sediment.			
Photograph ID: 36
